**Los Angeles County
Metropolitan Transportation Authority
Office of the Inspector General**

**Review of Metro
Safety Culture And Rail
Operational Safety**

Report No. 17-AUD-04

December 22, 2016

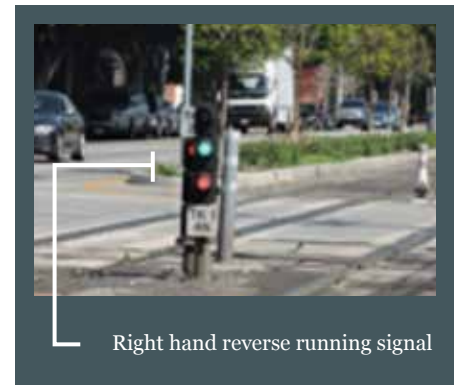
Although Metro has adopted a standard to install wayside signals on the left side of the track, many signal locations include right hand signals. This could lead to confusion on the part of train operators, especially at locations where normal and reverse running signals are installed side by side. Metro's representatives indicated that the main reason for this deviation is to separate interlocking signals from traffic signals. However, it should be noted that reverse running signals are facing opposite to train traffic, and should not be visible to automobile drivers.

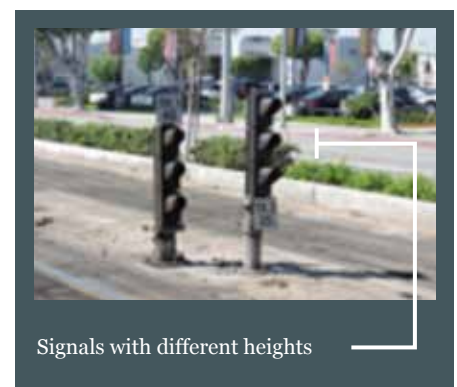
There is a lack of standards regarding the placement of wayside signals versus the Rail Operator's direct line of sight. Signal height, for example, varies from location to location and in some cases a signal is raised in an attempt to differentiate it from an adjacent signal. This condition was also observed by the APTA Peer Panel.

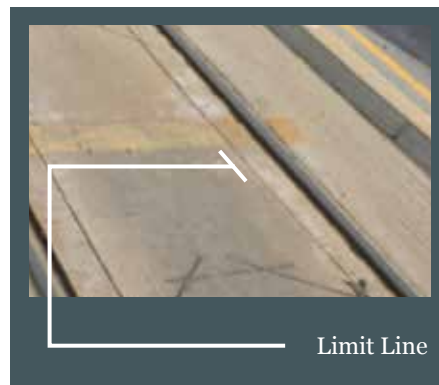
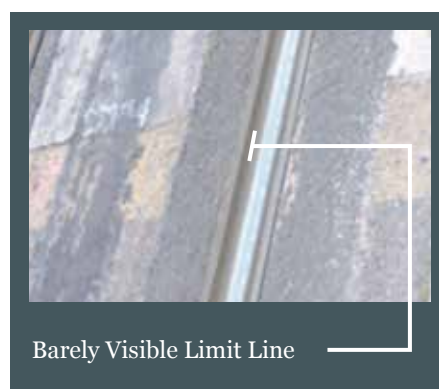
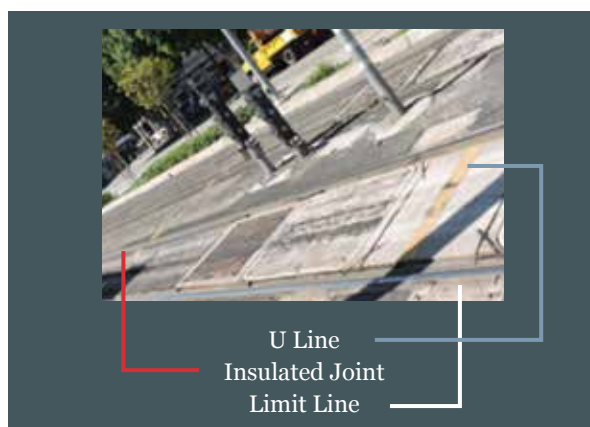
Further, at certain locations on the Expo Line, two yellow lines were observed in the vicinity of a signal location: the “Limit Line”, and a second line passed the signal at an insulated joint location (IJ Line).

A review of the Operating Rules and Procedures reveal that a “Limit Line” is not defined. However, a “Fouling Point Marker” is described. It is not clear if the “IJ Line” observed at certain locations is actually a “Fouling Point Marker”.

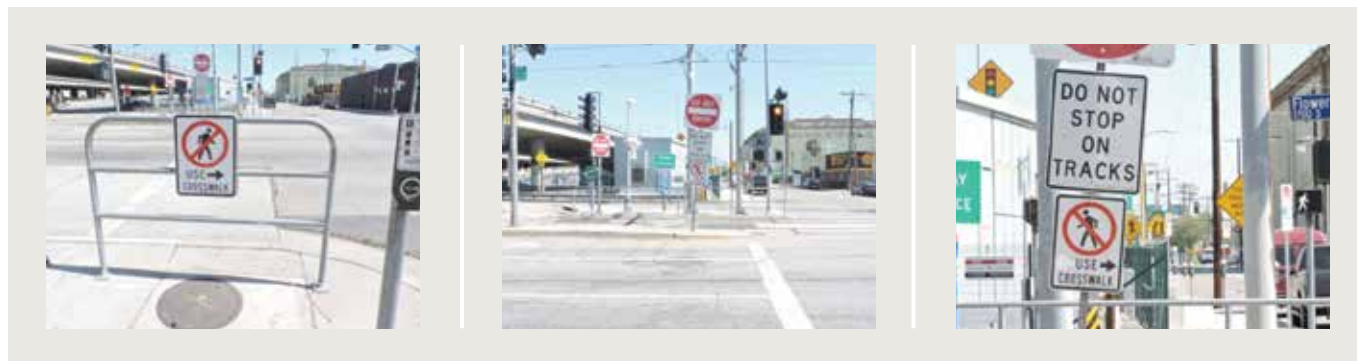
There are a number of pedestrian and vehicle signs that are missing at this intersection. They include:

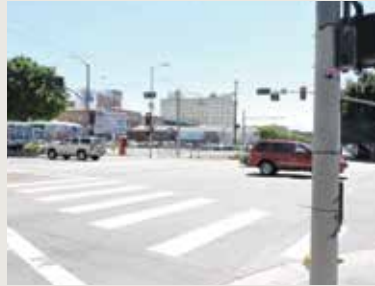
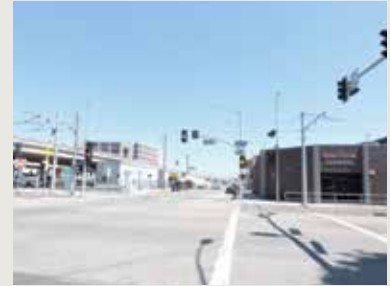
The street markings for pedestrians and vehicles at this intersection provide basic guidance for pedestrians, and are in fair condition.

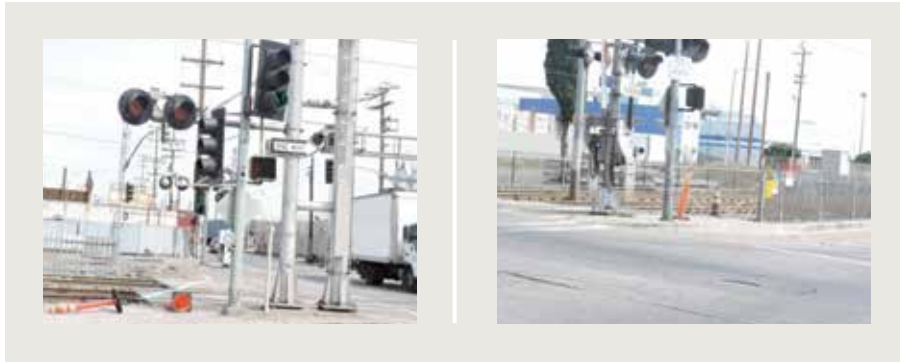
During our site visit at this location, we observed that the temporary identifier used to identify priority signal locations is placed on the right of way in an attempt to create a pedestrian barrier. It is not a good practice to use this temporary identifier in a different application that is not associated with a priority signal location. Such practice dilutes the safety intent of this temporary identifier.

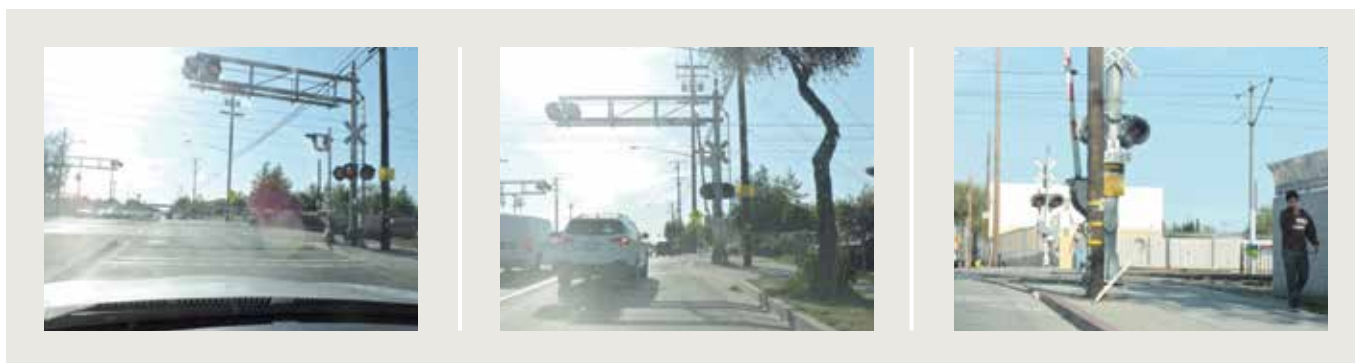
This intersection is equipped with basic crossing gates, flashing lights and bells for vehicles. Pedestrian flashing lights, gates and bells are provided only at one side of the intersection.

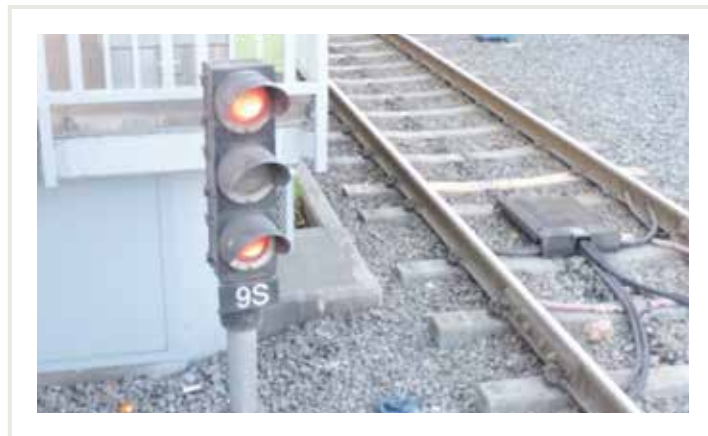
- Signal 9S is installed at the entrance to the station. Its function is to control the movement of a train into the station. It normally displays a FG/R (Flashing Green over Red) if there is no train at the platform. If a train is berthed at the platform, signal 9S displays R/R (Rule 3082). Also, this signal is located at the boundary between street running and ATP (cab-signaling) territory. There is a sharp curve in the approach to the signal, which results in a short sighting distance for the signal. Further, there is no enforcement at this signal, and safety of operation depends entirely on compliance with operating rules and procedures.

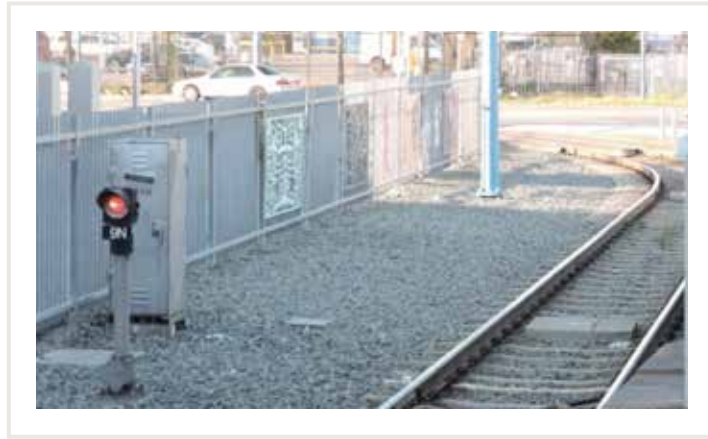
- Signal 9N is a reverse running signal located at the entrance to street running territory. It normally displays a “Red” aspect, and requires authorization from the ROC to proceed (Rule 3082). This signal is at the approach to a sharp curve.
