**Los Angeles County
Metropolitan Transportation Authority
Office of the Inspector General**

**Review of Metro
Safety Culture And Rail
Operational Safety**

Report No. 17-AUD-04

December 22, 2016

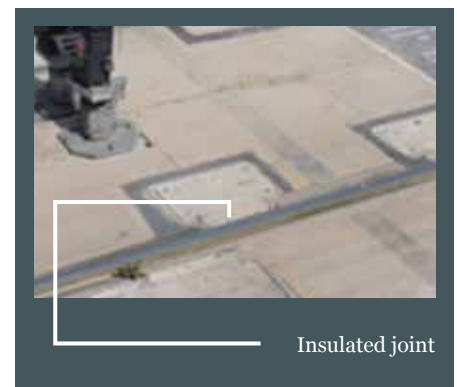
There is a lack of standards regarding the configuration of signal equipment at a signal location. For example, the relative location of the signal head versus the location of the insulated joint. On the Gold Line, insulated joints are located in advance of the signal head. However, on the Expo Line insulated joints are located after the signal head. It is important to establish an installation standard for insulated joints relative to the location of associated signal to ensure proper operation. A misplaced insulated joint could result in the cancellation of a signal in front of a train.

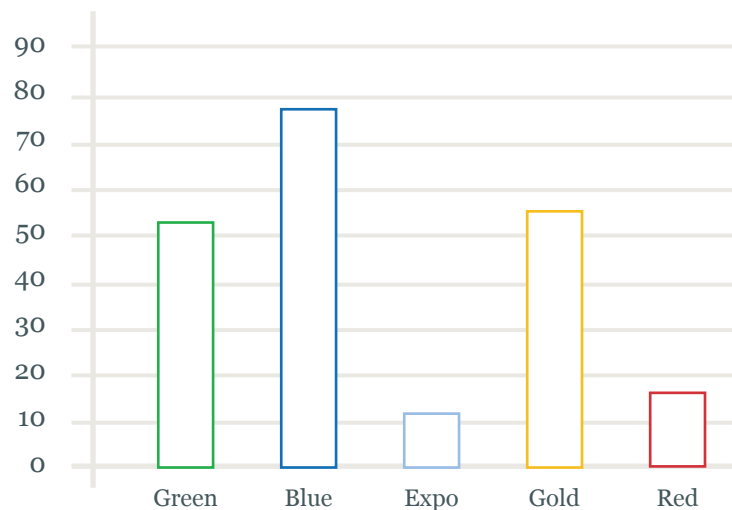
Metro Line	Total Failures	Characteristics
Blue	79	<ul style="list-style-type: none"> • Oldest signal installations - placed in service in July 1990 • 22 miles • Cab-signaling • Street running sections
Expo	12	<ul style="list-style-type: none"> • Newest signal installation - placed in service in April 2012 • 8.6 miles • Cab-signaling • Street running sections
Gold	55	<ul style="list-style-type: none"> • Placed in service in July 2013 • 31 miles • Cab-signaling distance to-go • Street running sections
Green	53	<ul style="list-style-type: none"> • Placed in service in April 1995 • 20 miles • Cab-signaling distance to-go • High level of automation • Dedicated right-of-way
Red	16	<ul style="list-style-type: none"> • Placed in service in January 1993 • 17.4 miles • Cab-signaling • Heavy rail installation

The following chart shows the distribution of signal failures for the various Metro lines:

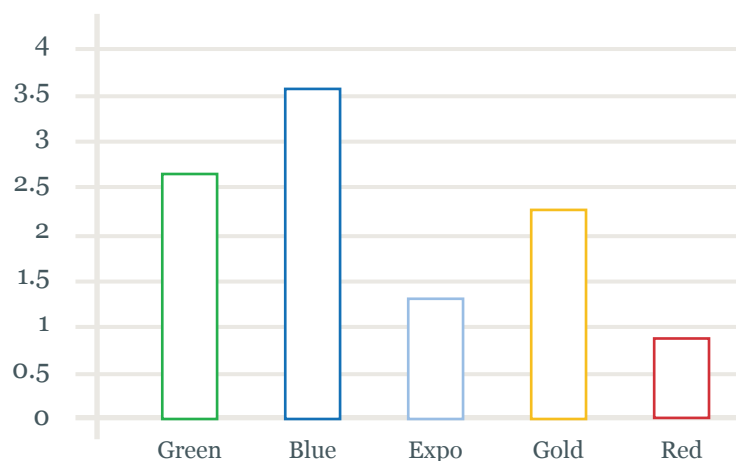
Metro Line	Total Failures	Track Miles	Failure/Mile
Blue	79	22.0	3.59
Expo	12	8.6	1.40
Gold	55	31.0	1.77
Green	53	20.0	2.65
Red	16	17.4	0.92

The following graph shows a failure per track mile distribution:

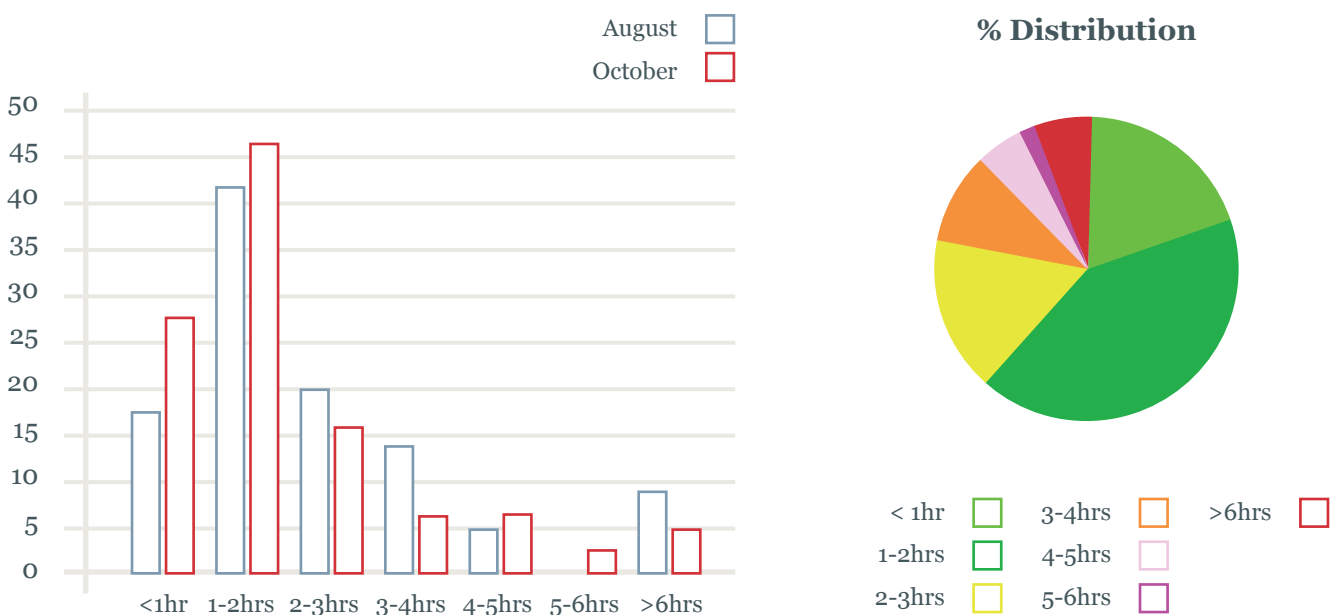
The above TTR distribution shows that approximately 78% of all signal failures are repaired within 3 hours, including travel time. It is difficult to compare TTRs for various transit properties as many parameters affecting TTR vary from property to property. Metro has not provided TWG with performance metrics related to signal maintenance efforts.

Approximately 5.6% of the incidents have a TTR in excess of six hours. A review of these incidents indicates that the associated signal failures required replacement of signal equipment and adjustments and/or troubleshooting intermittent failures, all of which are normally time consuming tasks.

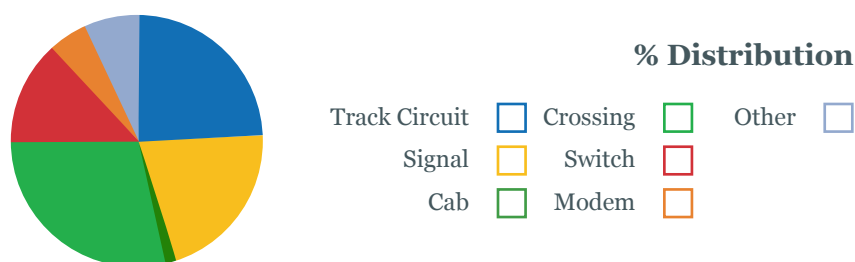
A graphic distribution of the main causes for signal failures is shown in the following chart:

The above distribution shows that over 70% of signal failures are caused by conventional signal equipment including track circuits, signals and grade crossing devices. This demonstrates the advantage of new train control technologies that minimize the use of conventional signal equipment.

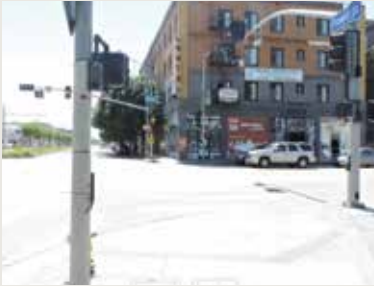
Street Markings

The street markings for pedestrians and vehicles at this intersection provide basic guidance for pedestrians, and are in fair condition.

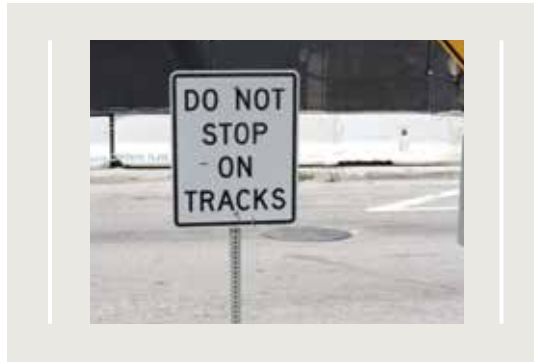
There are a number of pedestrian and vehicle signs that are missing at this intersection including:

- Advance warning signs, and
- No vehicle on track sign.

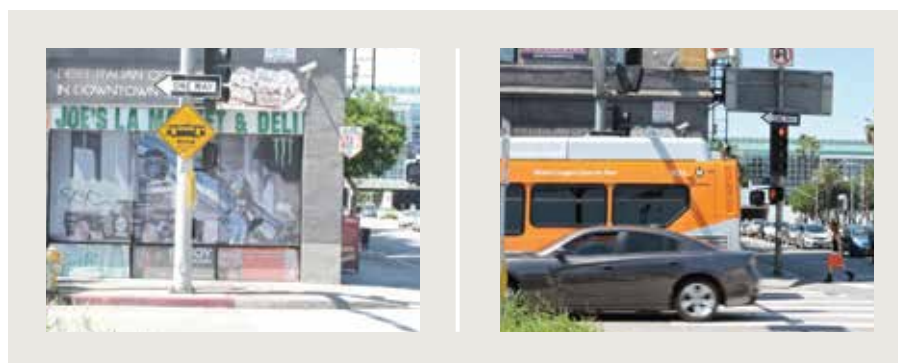
One of the “Look” signs is installed at a bus stop. When a bus makes a station stop, the sign is not visible.

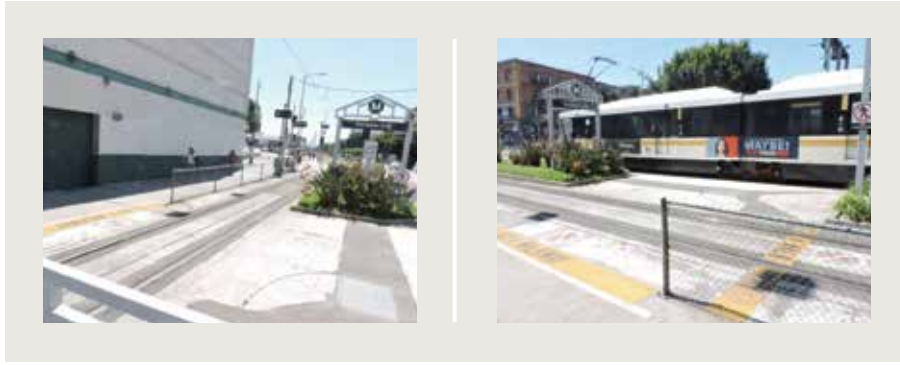
An unprotected private driveway exists at the south end of Pico Station. Based on the accident records provided by Metro, 12 accidents including one fatality occurred at driveways along Flower Street. The issue of unprotected private driveways was brought to the attention of Metro's Corporate Safety to ascertain if Metro took actions to mitigate the risks associated with these driveways.

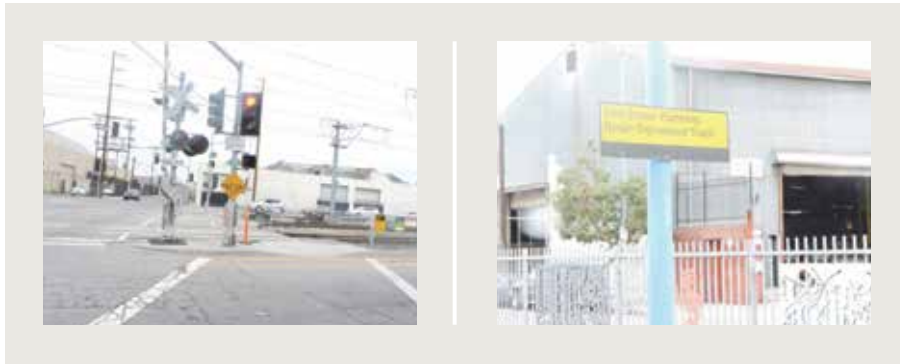
This intersection includes most of the basic vehicle and pedestrian signs, with the exception of the “No Vehicle on Track” sign and “Do not Stop on Track” sign.

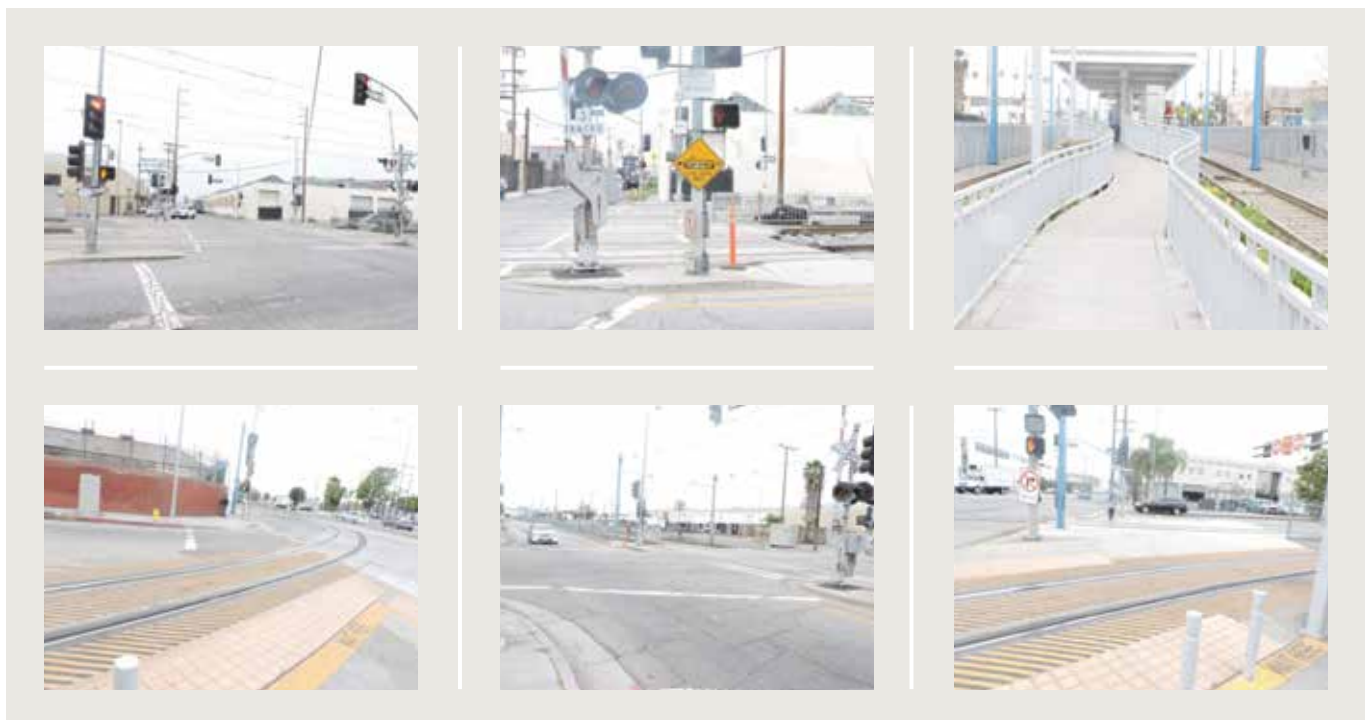
Street Markings

The 20th Street intersection (south end of Washington Station) does not have street markings or channelization to guide pedestrians through the crossing. Further, there is no street marking or treatment to mark the edge of the crossing. However, the north end of the station has channelization to guide pedestrians to exit the station. Further, street markings north of the station employ contrasting pavement color or texture for pedestrian crossings.

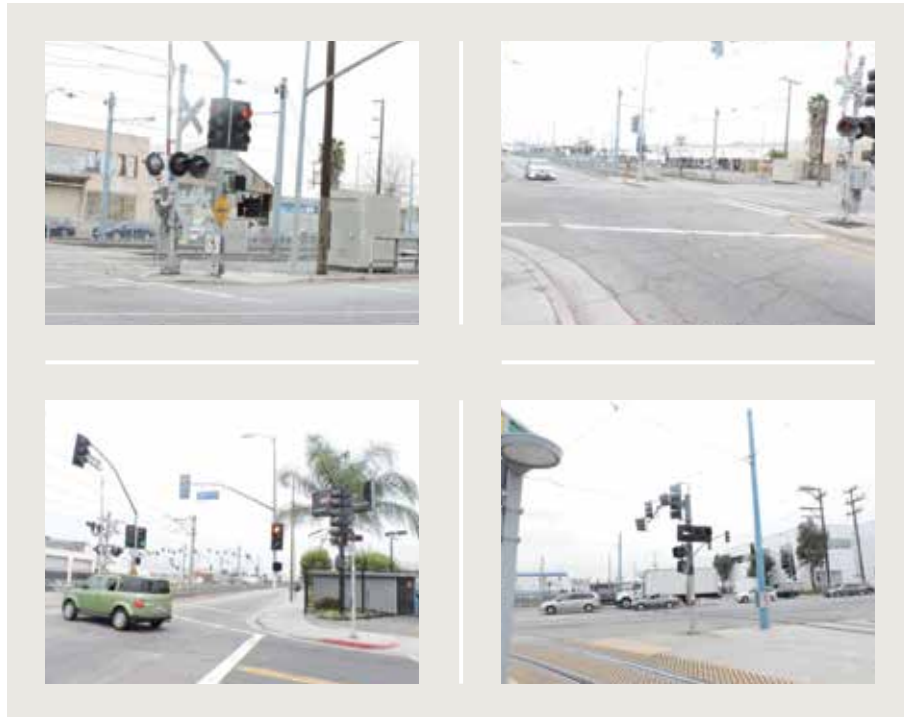
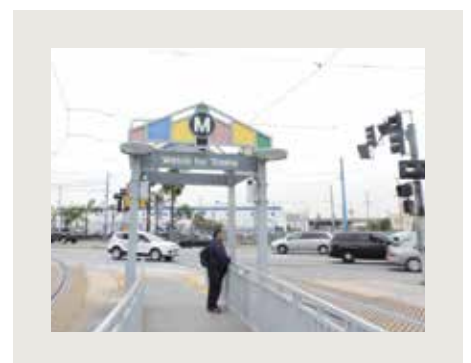
Traffic Equipment

The 20th Street intersection is equipped with basic crossing gates, flashing lights and bells for vehicles. There are no pedestrian flashing lights, gates or bells at this intersection. The only pedestrian crossing lights at this intersection are countdown lights that are manually activated by pedestrians.

Other than a sign for pedestrian to “Watch for Trains”, there is no other protection provided. Pedestrians are provided with a zone to wait for the clearing of the countdown crossing signals to clear. However, there are no provisions provided for pedestrians waiting between the tracks to activate the crossing signals.

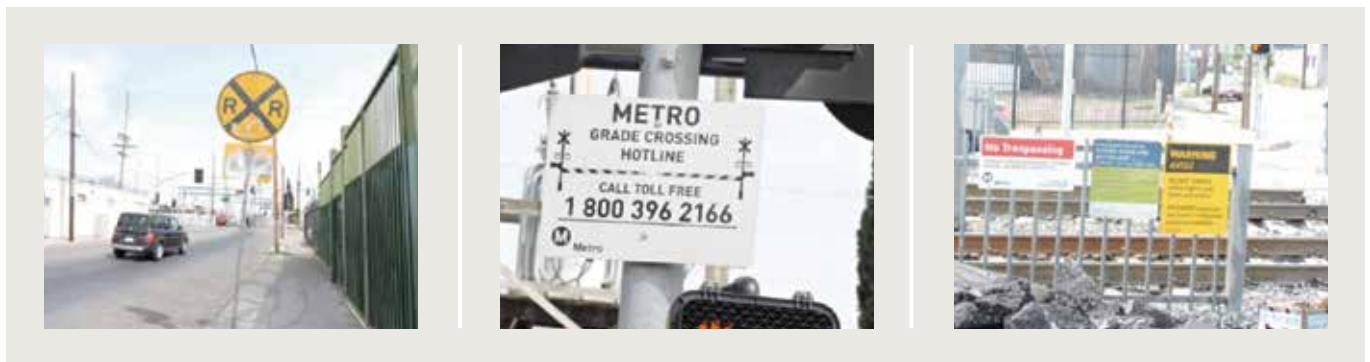
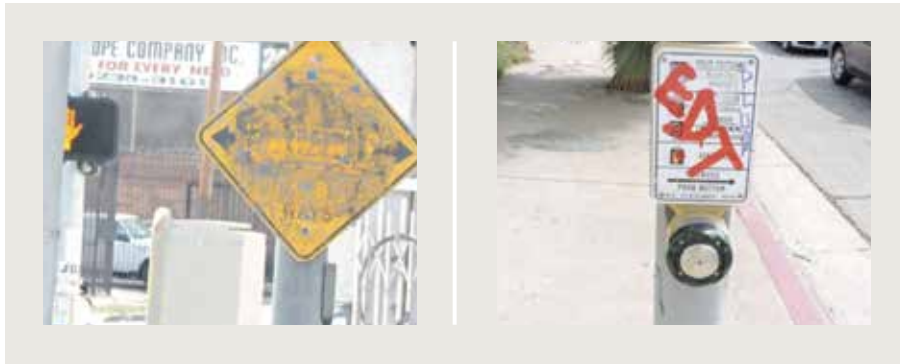
Signage

There are a number of pedestrian and vehicle signs that are not provided at this intersection. These includes:

- No vehicle on track sign,
- No pedestrian sign, and
- “Stop here when flashing” sign.

Further, a number of signs at this intersection are covered with graffiti.

To enhance the safety of operation at this location, it is essential to undertake measures that will discourage unsafe public behavior. This can be achieved through the installation of additional signs, street markings and traffic equipment, and by implementing a channelization scheme to guide pedestrians through the crossing. Further, the implementation of dynamic information related to approaching trains will inform the public when more than one train is approaching the intersection. *See appendix 8* for check list of a number of industry best practices to improve the safety at rail/vehicle intersections. It is believed that the implementation of a number of these measures at this location will help achieve an environment that will encourage safe public behavior.

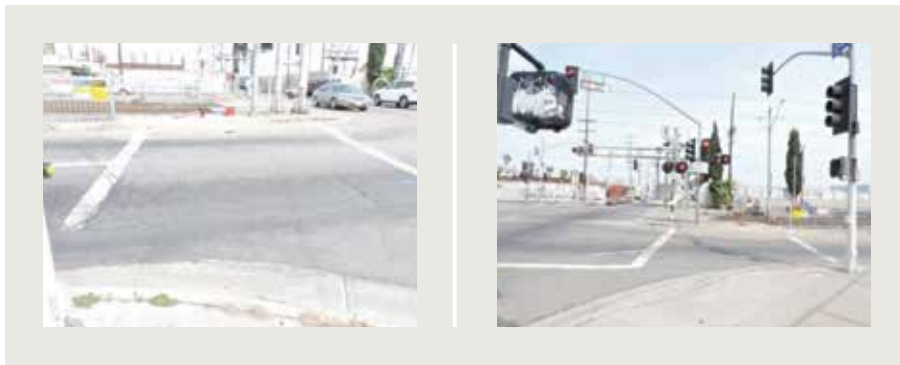
Street Markings

There are no street markings or channelization to guide pedestrians through the crossing. Further, there is no street markings or treatment to mark the edge of the crossing.

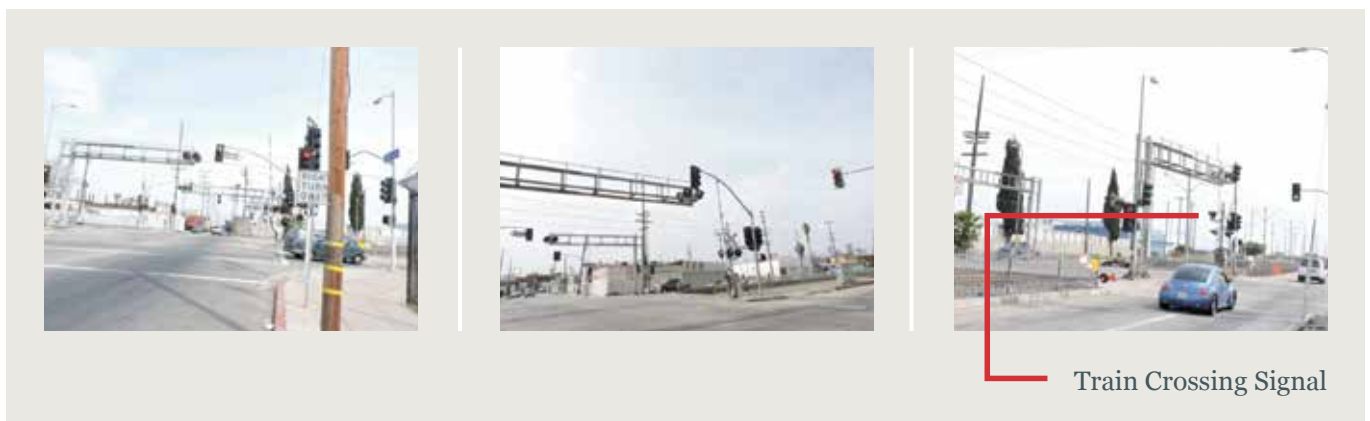
Crossing Equipment

This intersection is equipped with basic crossing gates, flashing lights and bells for vehicles. There are no pedestrian flashing lights, gates or bells at this intersection. The only pedestrian crossing lights at this intersection are countdown lights that are manually activated by pedestrians.

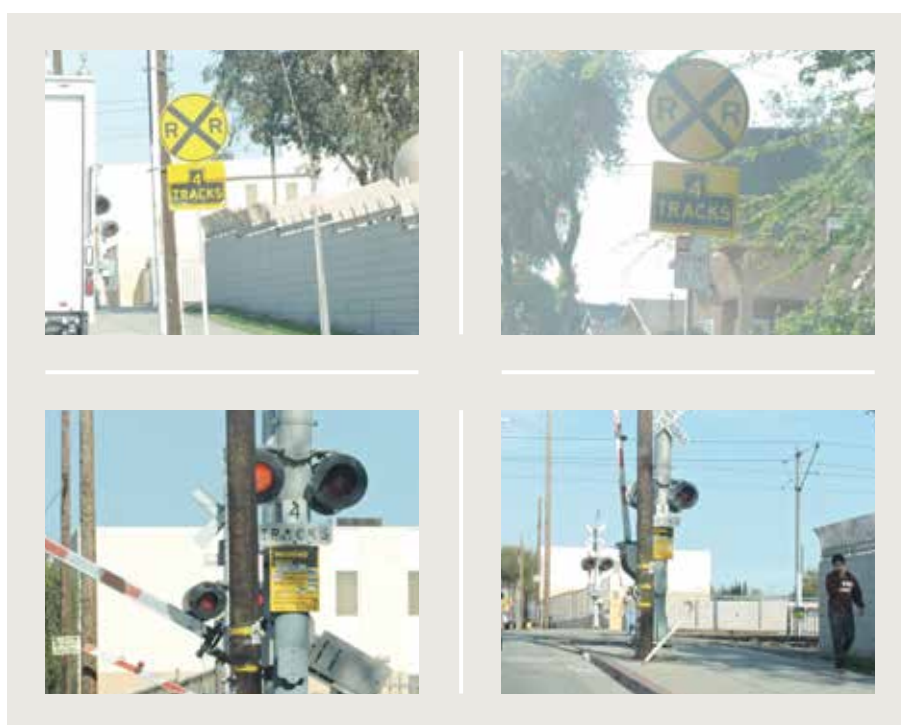
Signage

There are a number of pedestrian and vehicle signs that are not provided at this intersection. These include:

- Look signs,
- No vehicle on track sign,
- Emergency notification sign,
- No pedestrian sign, and
- “Stop here when flashing” sign.

To enhance the safety of operation at this location, it is essential to undertake measures that will discourage public unsafe behavior. This can be achieved through the installation of additional signs, street markings & traffic equipment, and by implementing a channelization scheme to guide pedestrians through the crossing. Further, the implementation of dynamic information related to approaching trains will inform the public when more than one train is approaching the intersection. A contributing factor to one fatality at this intersection is related to a second train that struck a pedestrian. Appendix 8 identifies a number of industry best practices to improve the safety at rail/vehicle intersections. The implementation of a number of these measures at this location will help achieve an environment that will encourage safe public behavior.

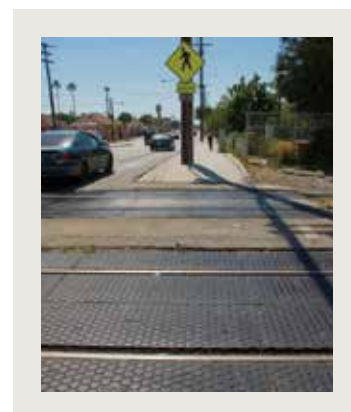
Street Markings

Crossing protection to pedestrians is only provided at one side of the intersection. There are no street markings or channelization to guide pedestrians through the crossing. Further, there is no street marking or treatment to mark the edge of the crossing.

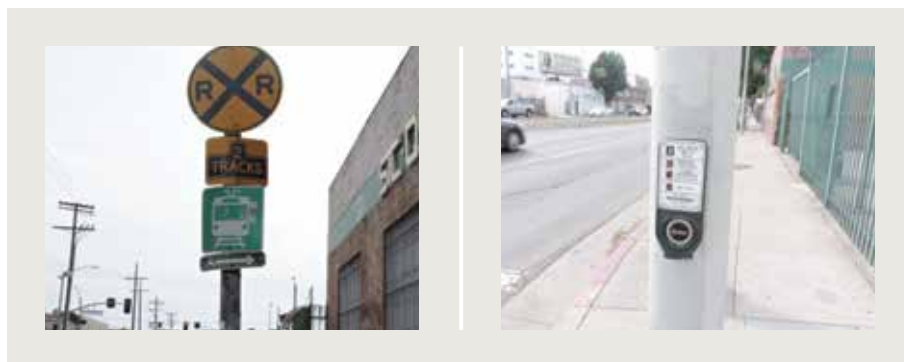
Signage

There are a number of pedestrian and vehicle signs that are not provided at this intersection. They include:

- Look sign,
- No vehicle on track sign,
- Stop here on red sign,
- “Suicide Crisis Line” sign,
- No pedestrian sign, and
- “Stop here when flashing” sign.

The main factor that contributed to prior accidents is unsafe behavior by the public in violating traffic signals. To enhance the safety of operations at this intersection, it is essential to undertake measures that will discourage unsafe public behavior. There is a need to focus on improving the signage and dynamic information provided to the public, as well as the implementation of traffic enforcement measures. Appendix 8 identifies a number of industry best practices to improve the safety at rail/vehicle intersections. Implementing a number of the identified measures will help achieve an environment that encourages safe public behavior.

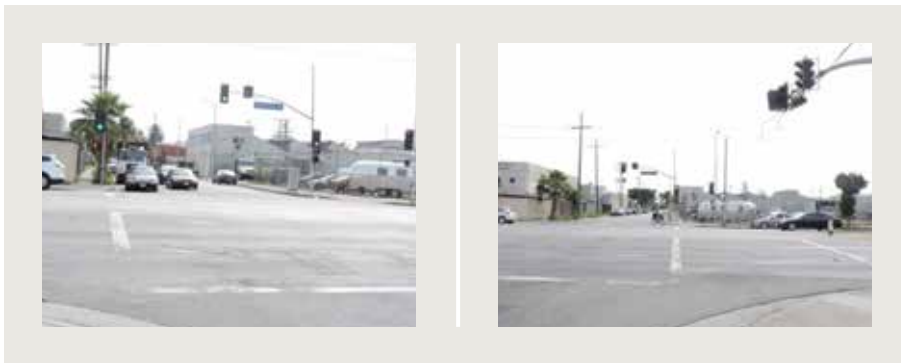
Street Marking

There are no street markings or channelization to guide pedestrians to cross the tracks, and pedestrian street markings are fading and need to be repainted.

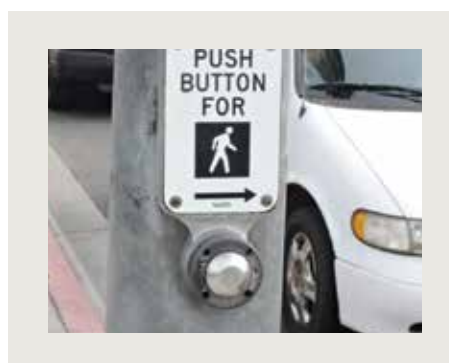
Signage

There are a number of pedestrian and vehicle signs that are missing at this intersection. They include:

- Advance warning signs,
- Look signs,
- No vehicle on track sign,
- No pedestrian sign,
- Do not stop on track sign,
- Stop here on red sign, and
- Suicide crisis line sign.

- Installation of blank out no left turn sign,
- Installation of a second train signal to advise motorists and pedestrians that two trains are approaching an intersection,
- Installation of illuminated active in-pavement marking (IPM) systems, and
- Installation of traffic enforcement devices.

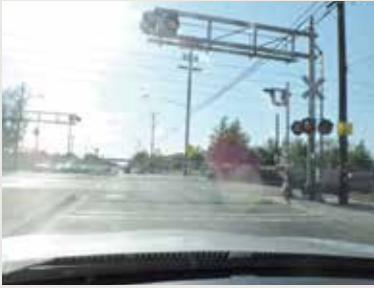
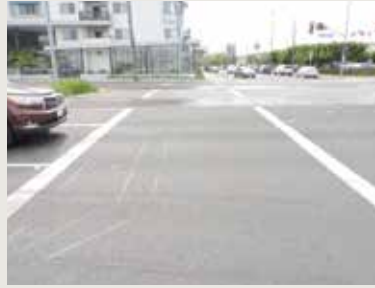
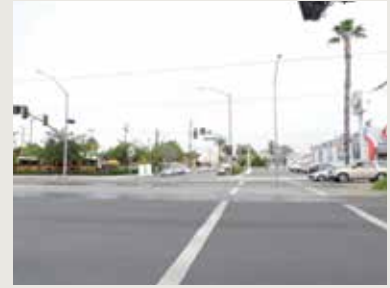
Street Markings

There are no street markings or channelization to guide pedestrians through the crossing. Further, there is no street marking or treatment to mark the edge of the crossing.

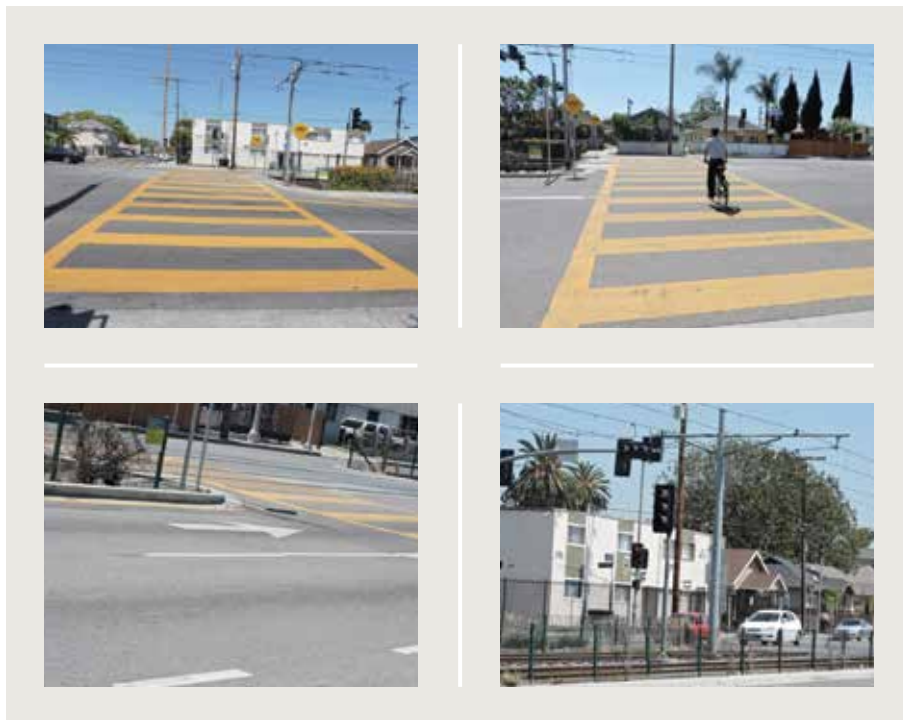
Street Markings

The street markings for pedestrians and vehicles at this intersection provide basic guidance for pedestrians to cross the tracks, and are in fair condition.

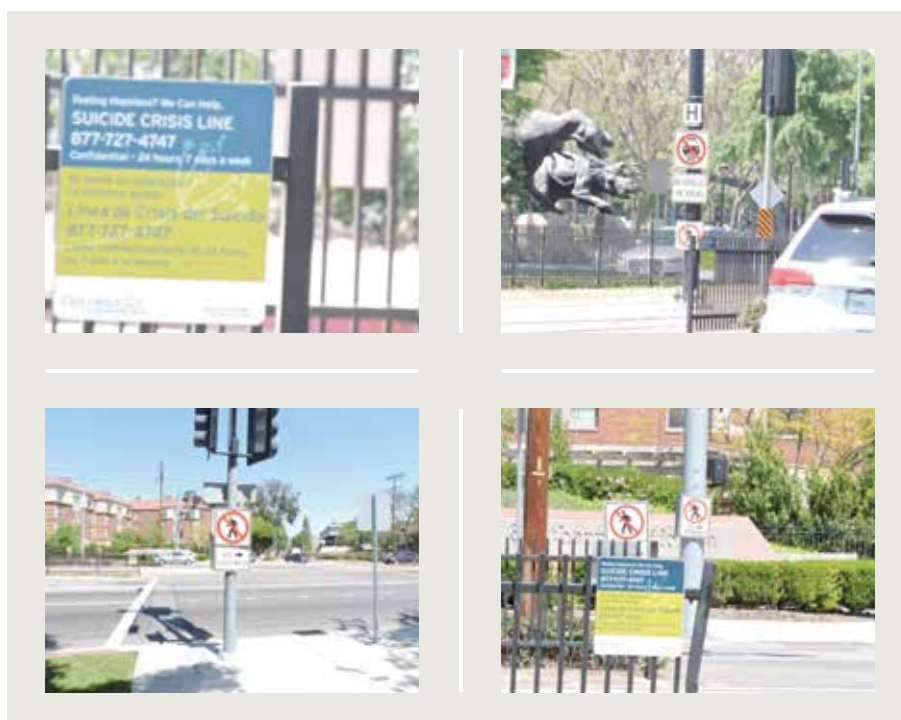
Signage

There are a number of pedestrian and vehicle signs that are missing at this intersection. They include:

- Advance warning signs, and
- Look signs.

As indicated above the main factor that contributed to the prior accidents was the unsafe behavior by drivers violating traffic signals. In order to improve the safety of operations at the intersection there is a need to focus on improving the signage and dynamic information provided to the public. Appendix 8 identifies a number of industry best practices to improve the safety at rail/vehicle intersections. It is believed that the following measures will help achieve an environment that will encourage public safe behavior:

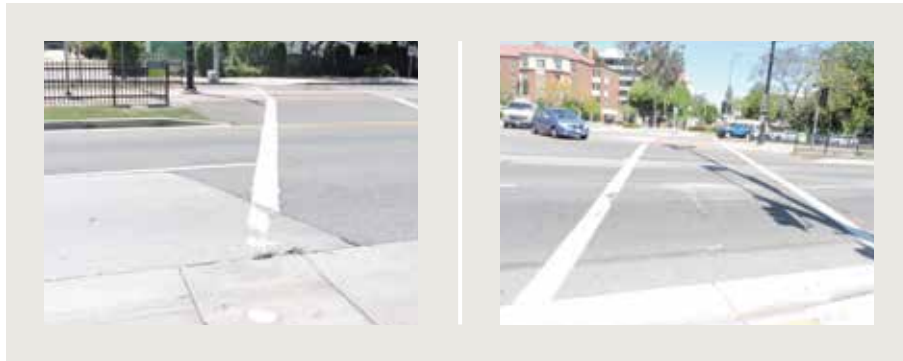
Street Markings

There are only fading white lines to mark the pedestrian crossing. There is no channelization to guide pedestrians through the crossing.

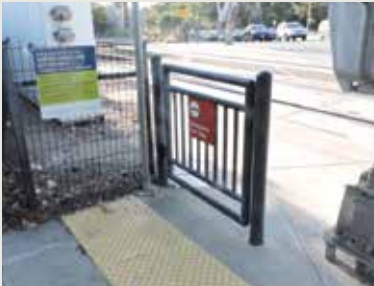
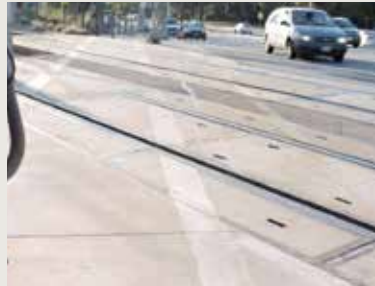
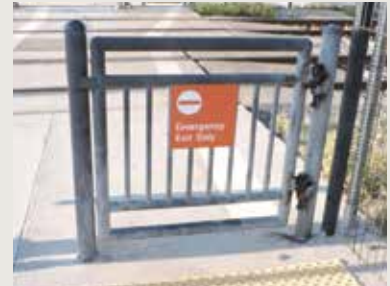
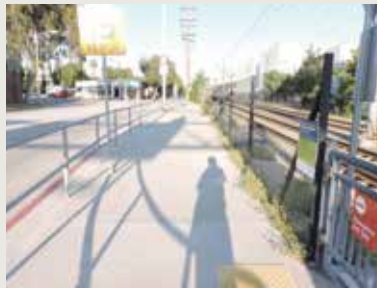
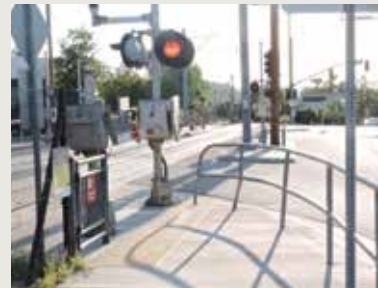
Street Markings

Adequate crossing protection is provided to pedestrians, including channelization to guide pedestrians through the crossing and swing gates. However, street markings within the intersection are fading away.

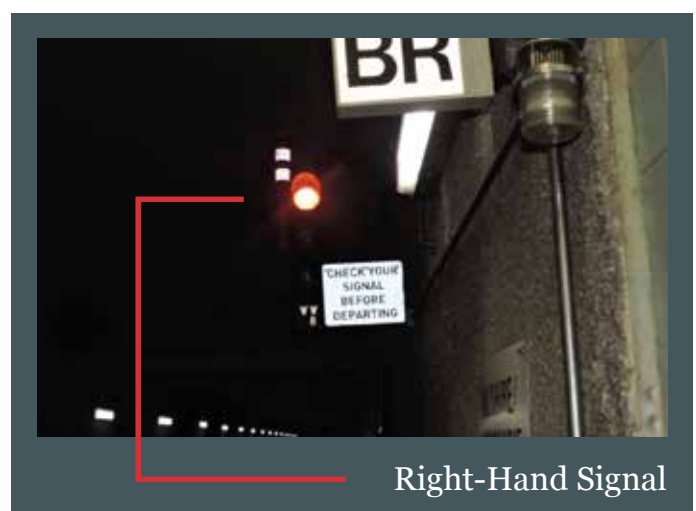
- Although Metro signal standards require signals to be installed on the left of the track, Signal 8 is a right hand signal,

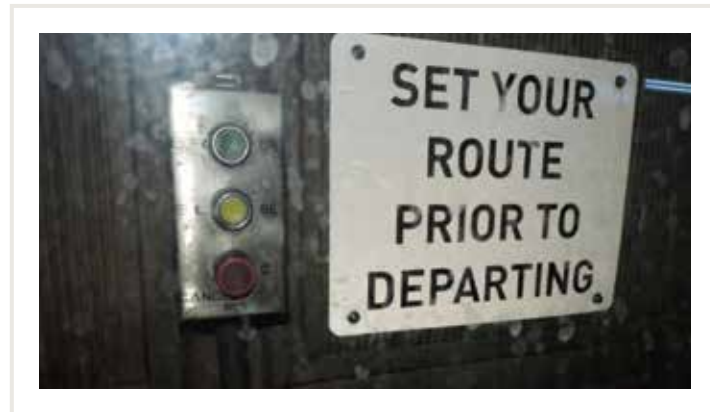
- The motorman pushbutton at the location does not include an indicator to inform the train operator if it is necessary to establish the route at the signal, and

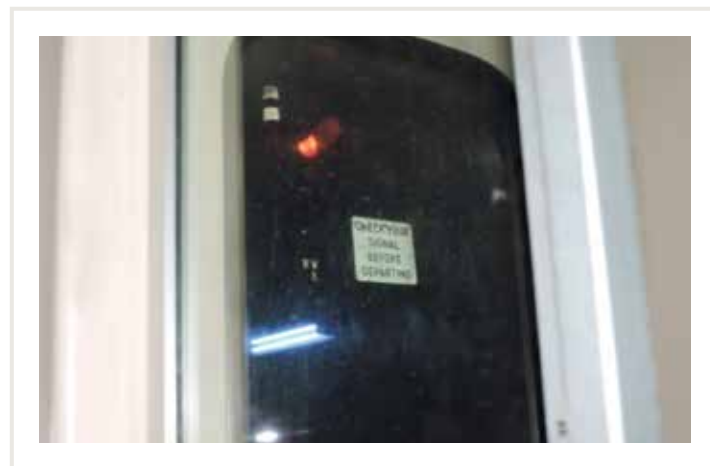
- When the train operator's cab is aligned with the motorman pushbutton location, Signal 8 is not visible from the train operator's position. The train operator needs to lean to the right side of the cab to see the signal.

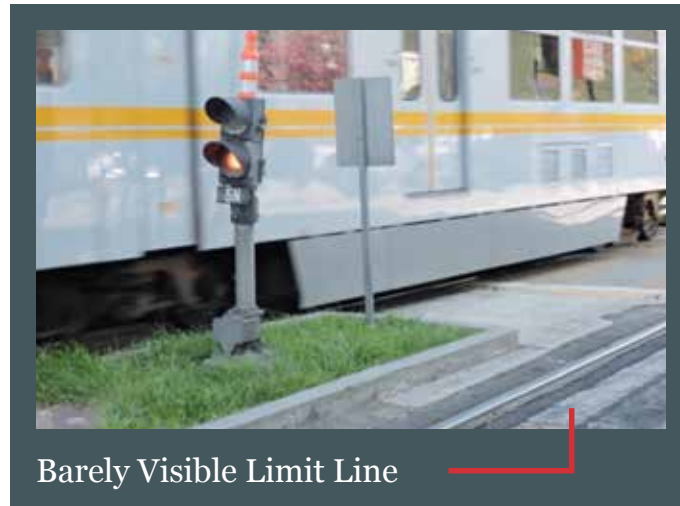
- The bar signal at the intersection changes very quickly,
- The Limit Line at the signal location is barely visible, and
- The signal remains “Green” until the train crosses the intersection.

While the Limit Line should be repainted, a violation of the limit line by itself does not register as a red signal violation because the controlling track circuit is located at least 50 feet north of the signal location. However, if the train stops past the limit line, then it will be difficult for train operator to see signal 5N. Upon the clearing of the bar signal at the intersection, and the movement of the train past the intersection, a red signal violation will register when the train passes the insulated joint for track circuit 15T.

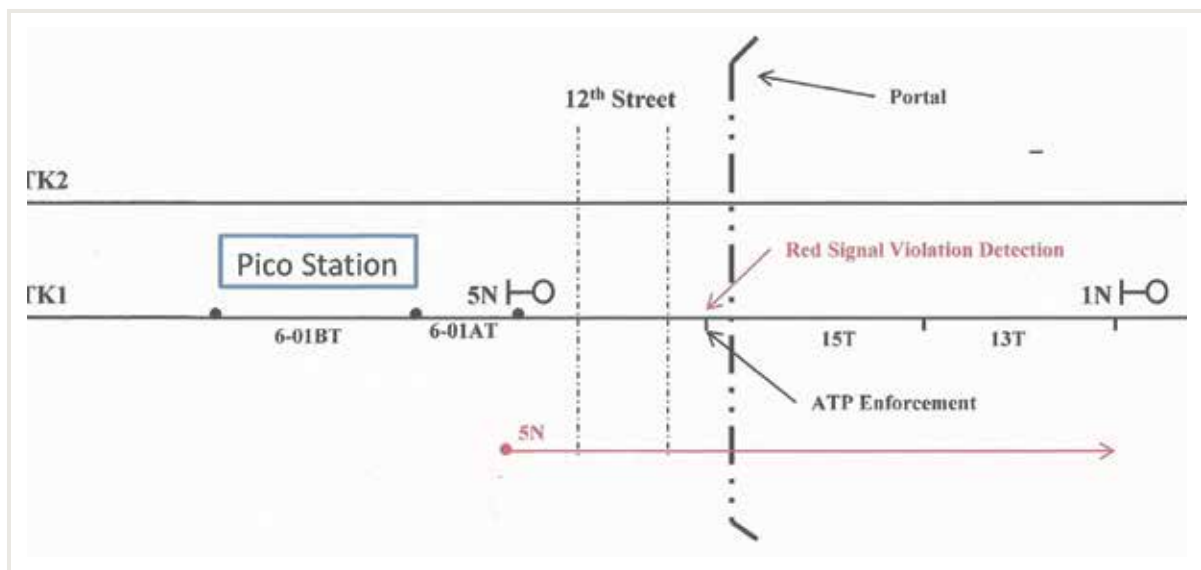
Safety Hazard at Signal 5N

As indicated above, there is a risk of train to train collision at Signal 5N. The following simplified drawing shows the main elements of the signal configuration between Pico Station and interlocking signal 1N in the approach to 7th & Metro Terminal Station:

- As indicated above, Signal 5N operates as an automatic signal (block signal control) to provide train separation for trains entering the portal. Signal 5N displays a “stop” aspect if either 15T or 13T is occupied.

- There is no enforcement at Signal 5N. However, ATP enforcement starts at 15T.
- During 2012 through 2015, there were 9 red signal violations at Signal 5N.

In view of the finding of this safety hazard, TWG brought this issue to Metro's attention on April 10, 2016, and recommended that for Metro to issue a safety advisory instructing train operators to operate at a reduced speed in the approach to the portal. In response, Metro took immediate action to mitigate this hazard, including:

TWG further recommended to Metro to conduct a braking test that verifies the initial hazard condition and the mitigation implemented by Metro. In addition, TWG recommended for Metro to install a speed sign of 20 mph in the approach to the portal.

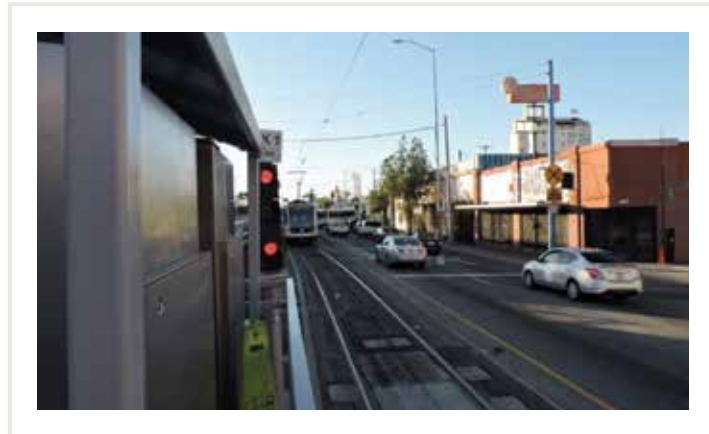
With respect to northbound signal 8N, it is partially obstructed by automatic vending machines installed at the north end of Grand/LATTC Station.

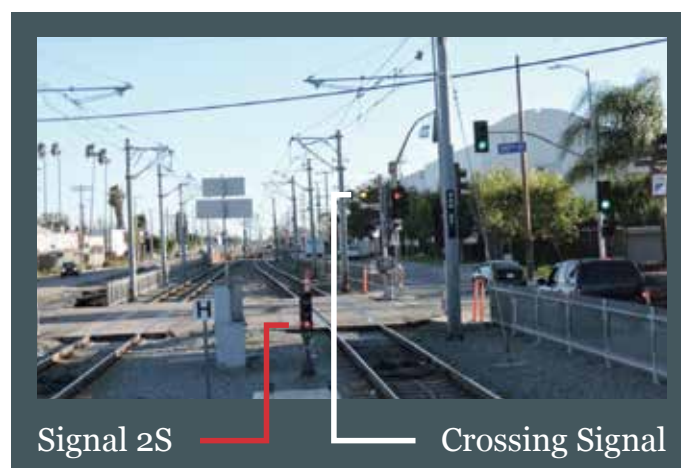
- There is potential for human error due to frequent occurrence of gate failure, and the need to rely on rules and procedures to operate through the crossing,
- Signal 2S is not clearly visible. The Stop Signal Working Group recommended to either raise the signal, or relocate it to the platform.

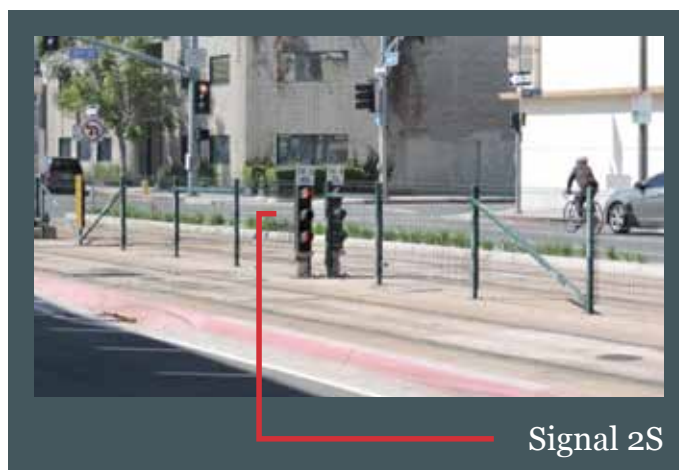
The normal and reverse running signals 2S & 4S are installed side-by-side, and are located in the approach to the 21st Street intersection. A traffic Bar Signal is located at the far right corner of the intersection, and operates independently of the interlocking signals. The ROC Controller SOPs indicate that this interlocking does not have an “Automatic” mode and that during normal operation, the interlocking remains in “Central” mode with signals 2S and 4N fleted.

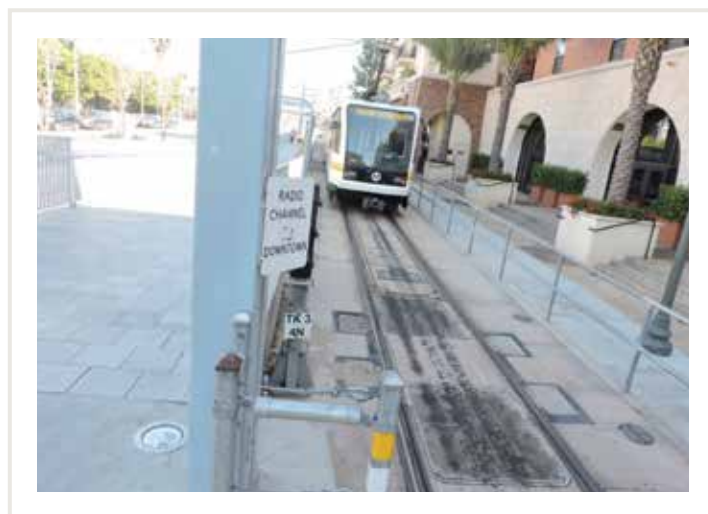
- Reverse running signal 4S is installed on the right side of the track,
- There is a slight curve in the approach to signal 2S, and
- A “radio” sign is partially obstructing signal 4N at the north end of the station.

The Stop Signal Working Group did identify the curve in the approach to Signal 2S as a potential contributor to red signal violation. It was indicated that it is difficult to see the signal from 500 feet. However, the signal representative indicated that there is a restricted speed approaching the station, and train operators should be slowing down.

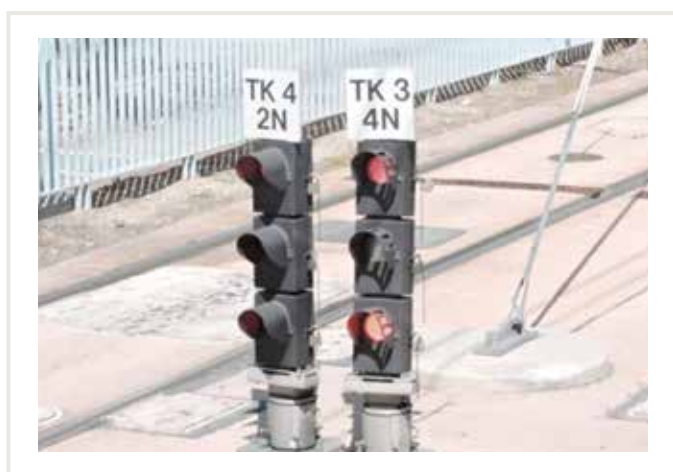
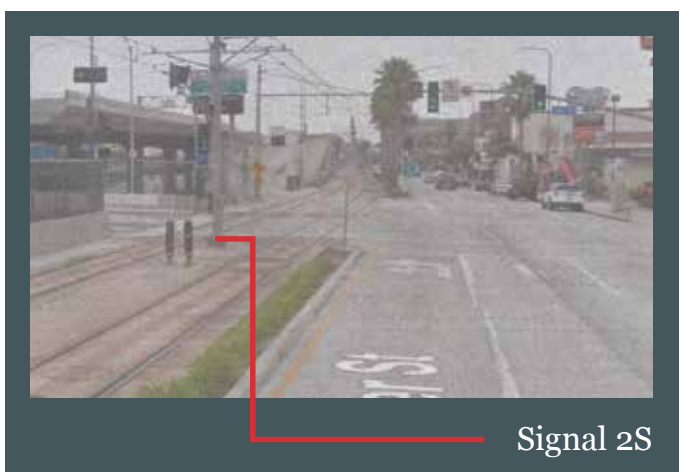
- Reverse running signals 2N & 4S are installed on the right side of the track,
- Good visibility for signals 2S & 4S. However, there is a slight curve in the approach to the signals, and
- Good visibility for signals 2N & 4N.

The Stop Signal Working Group made reference of the curve in the approach to Signals 2S & 4S. The group also observed that Signals 2N & 4N are too low and recommended raising the signals.

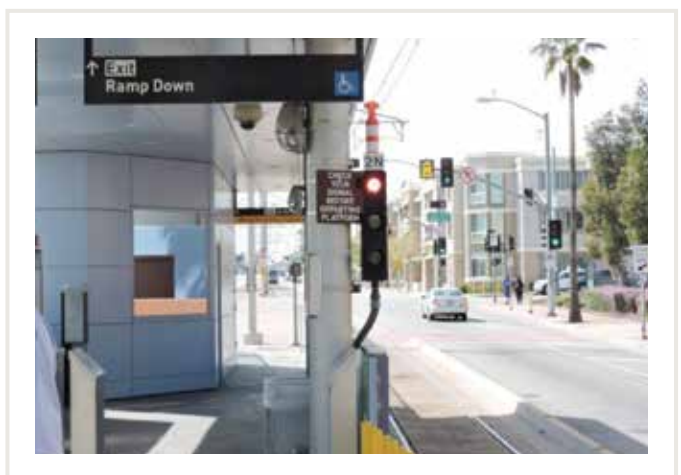
- Reverse running signal 2S is installed on the right side of the track,
- Good visibility for signals 2N & 4N, and
- Good visibility for signals 2S & 4S.

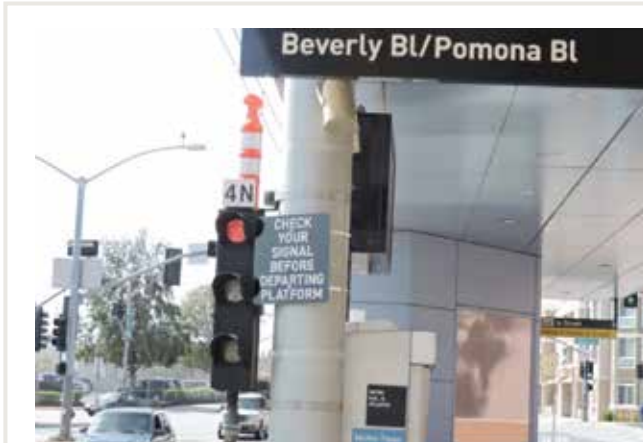
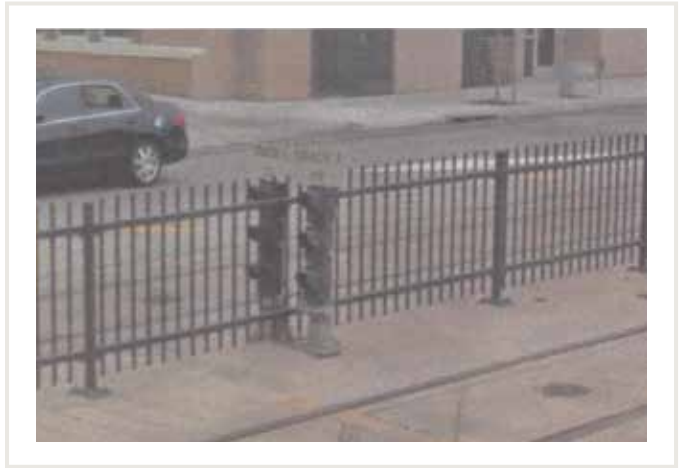
The Stop Signal Working Group made a number of observations related to the angle/orientation at the various signals. Further, the group questioned if the 500 feet sighting distance requirement is satisfied at signals 2S & 4S.

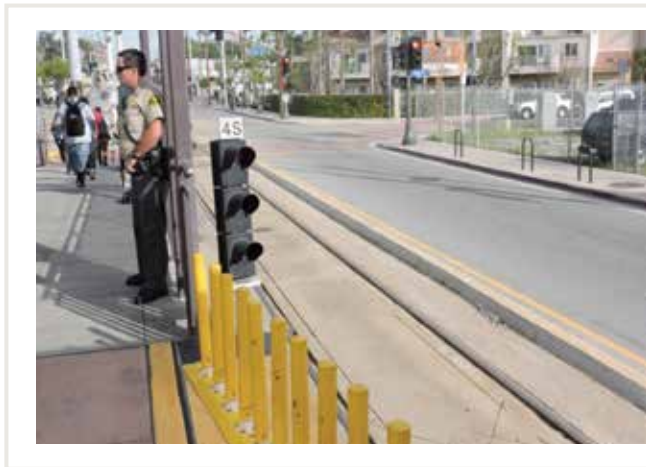
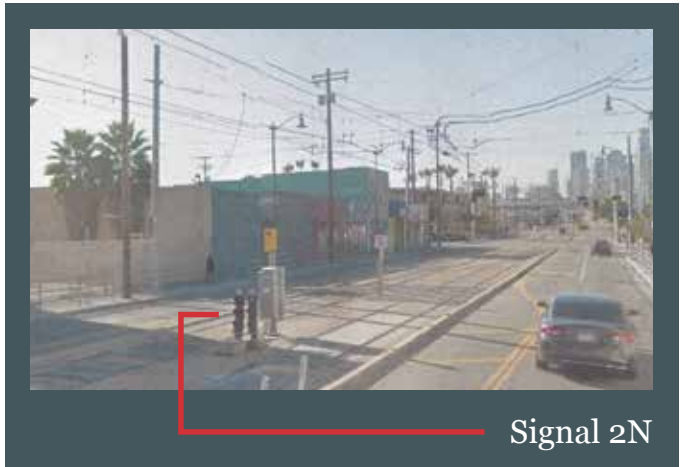
The Stop Signal Working Group noted that the barrier is partially obstructing the view of Signal 4S.

There are no site specific factors that contribute to red signal violations. Although Signal 4S is partially obstructed, the signal is visible when a train is stopped at the station. However, similar to other locations, there are operational factors that can contribute to the violations:

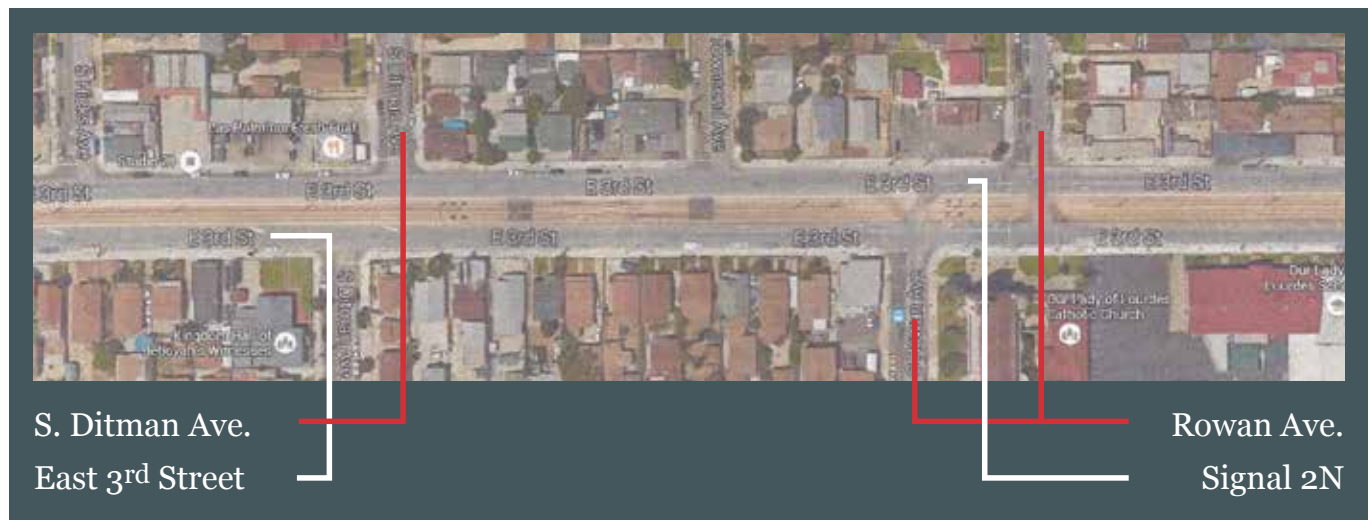
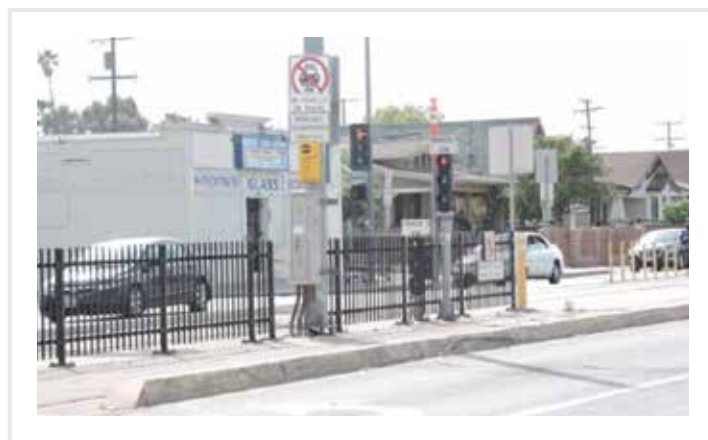
Signal 2N, where all the violations occurred, is located between two street intersections with Rowan Ave. There is a first Bar Signal (#1) located at the left side of the track in the approach to signal 2N, and a second Bar Signal (# 2) located at the right side of the track in front of Signal 2N. Similar to other locations, interlocking signal 2N and the Bar Signals operate independent of each other.

A54: Metro should investigate the feasibility of relocating Signals 2N and 4N to the south side of the first Rowan intersection. It should be noted that the installation of an approach signal to Signal 2N does not provide advance indication to train operators because Signal 2N is approach clearing and will normally display a “stop” aspect without a train present on the approach track circuit.
