**Bus Operator Safety Barrier
Use and Effectiveness Study**

Report No. 19-AUD-08

**BUS OPERATOR SAFETY
BARRIER USE AND
EFFECTIVENESS STUDY**

**Submitted by
ADS System Safety Consulting, LLC**

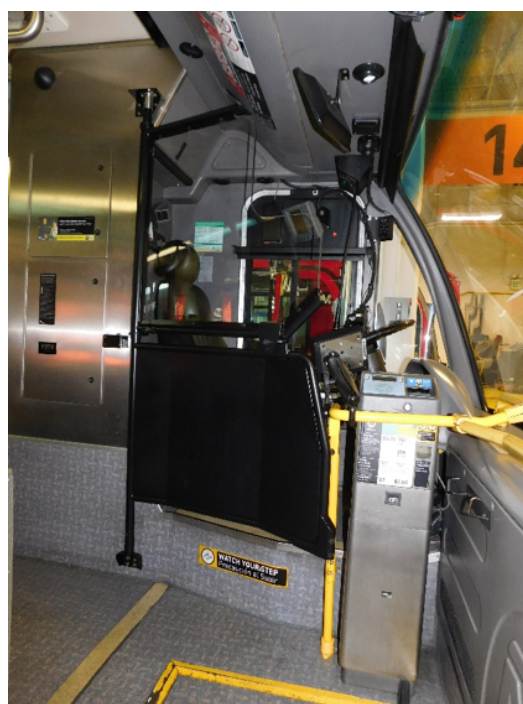
Figure 1.2.4: Both Barriers Engaged

Note: For the barrier systems installed by Metro, the lower portion of the barrier must be closed in the “used position” because it only opens 90 degrees, and thus would block the aisle for passengers.

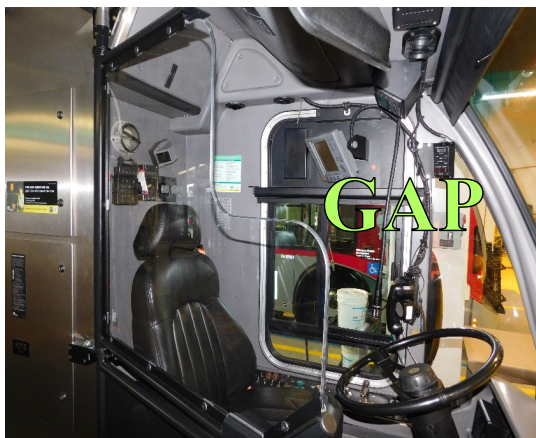
Figure 7.0.1

Approximately 72% of the bus operators and 75% of bus Supervisors and Managers surveyed felt the barriers were somewhat to very effective in preventing assaults. However, 53% of all bus operators surveyed and 62% of all bus Supervisors and Managers surveyed stated that additional protective measures were needed in addition to the safety barriers. A number of bus operators noted that the current safety barriers have gaps that they felt left them vulnerable to assaults. These gaps can be seen in **Figures 7.0.1 and 7.0.2**.
